# SEA LETTER

Published Quarterly by the San Francisco Maritime Museum

Foot of Polk Street, San Francisco . . . No. 1, Spring, 1960

## RUST . . .

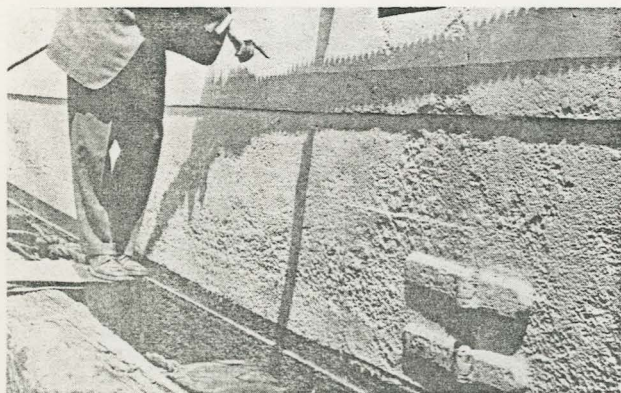
When, in 1955, the thickest areas of scale were cleaned by sand-blasting, it was found that underneath the scale active corrosion had drilled in like cancer. In time this pitted plating will be renewed.

Behind the scale active corrosion drilled in like cancer. When we bought the ship and knocked the scale away in 1954-1955 the hull was deeply pitted. We found the steel plates actually holed at the bottom of some of these pits. This was in the topside area, most of it at the level of the 'tween decks.

wind and water was sandblasted and painted. The topsides were sandblasted and painted from floats after the ship went back into the water. Where the hull was actually holed from corrosion at the waterline or below it, new plates were welded on outside—full and partial plates to the number of about a dozen. These were 1/4 inch thick. Where pitting had penetrated right through the topside plating, small patches, about a foot square, were welded on the inside of the hull. These numbered a couple of score.

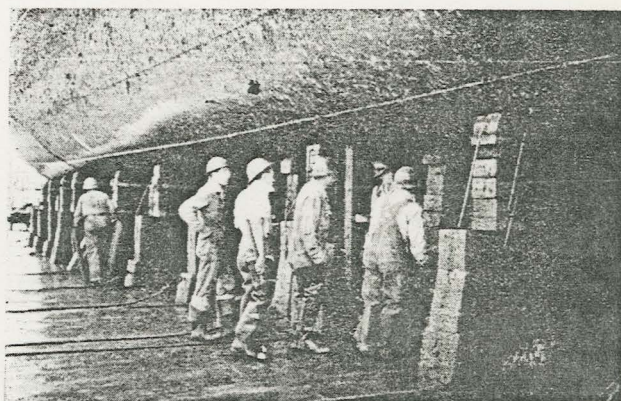
The bottom of BALCLUTHA was found to be in remarkably good condition when the ship was drydocked by Bethlehem shipyard in 1954. Areas subsequently tested by audio gauge showed that the bottom plates had thinned only 5% near the keel and 15% at the turn of the bilge.

Here was good news! The Alaska Packers shore gangs had coated the bottom with an average 3" of concrete. Chipped away this revealed bright metal. And the audio gauge revealed that in the areas tested the bottom plates had thinned only 5% near the keel and 15% at the turn of the bilge.
